Home Report

Single Survey

Property address	127 Maxwellton Avenue East Kilbride Glasgow G74 3DU
Customer	Jan Robertson
Customer address	127 Maxwellton Avenue East Kilbride Glasgow G74 3DU
Prepared by	Shepherd Chartered Surveyors
Date of inspection	17/07/2025

Survey Report

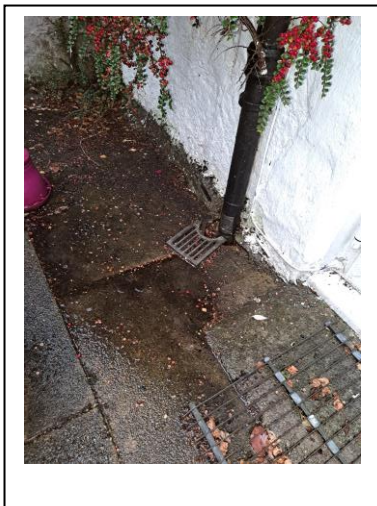
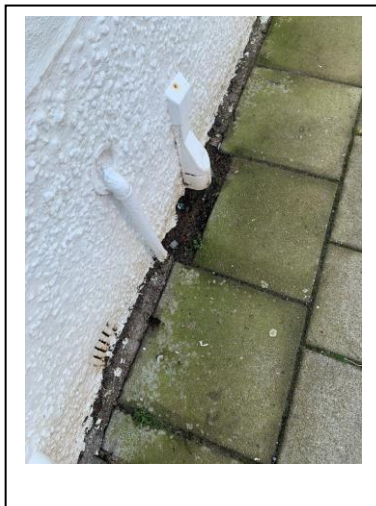
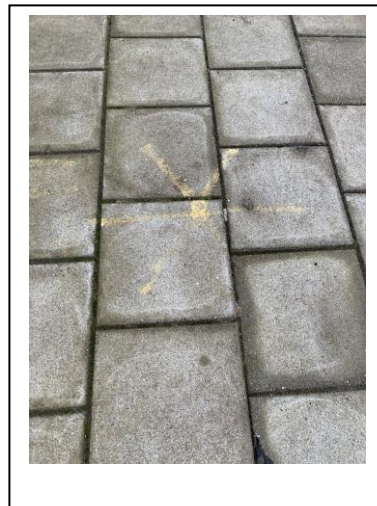
Survey images

Dampness in the form of penetrating damp exists on walls as discussed at the time of survey. This dampness would appear to be the result of apparent transfer of moisture from external fabrics. This issue may have been elevated due to external service works being carried out to pavement on front elevation and contact with exposed stone wall allowing moisture to contaminate wall fabrics.

Dampness was also noted to lower section of wall at rear doorway. We recommend you inspect competent tradesperson to inspect and repair any possible defects to door seals to prevent penetrating damp.
