HOME
report

SINGLE SURVEY
ENERGY REPORT
PROPERTY QUESTIONNAIRE
VALUATION REPORT

Single Survey

Property address	27 Woodlands Court, Thornliebank, Glasgow, G46 7SA
-------------------------	---

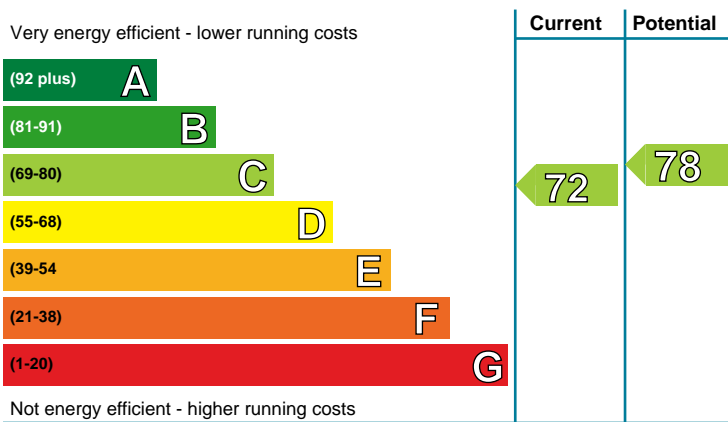
Energy Efficiency Rating

This graph shows the current efficiency of your home, taking into account both energy efficiency and fuel costs. The higher this rating, the lower your fuel bills are likely to be.

Your current rating is **band C (72)**. The average rating for EPCs in Scotland is **band D (61)**.

The potential rating shows the effect of undertaking all of the improvement measures listed within your recommendations report.

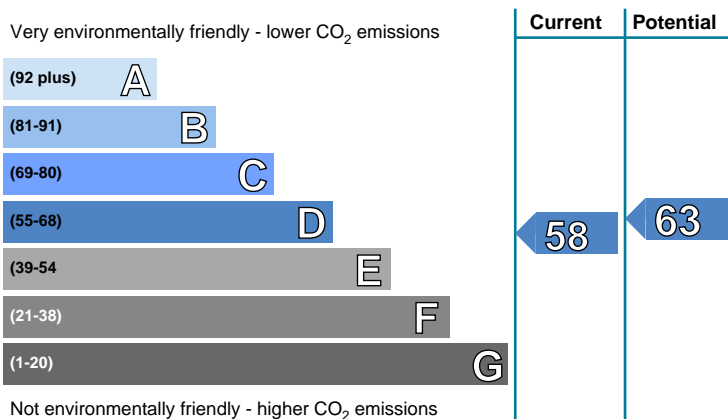
Environmental Impact (CO₂) Rating

This graph shows the effect of your home on the environment in terms of carbon dioxide (CO₂) emissions. The higher the rating, the less impact it has on the environment.
