HOME REPORT

27 FRANKLIN PLACE
EAST KILBRIDE
GLASGOW
G75 8LT

Energy Performance Certificate (EPC)

Single Survey

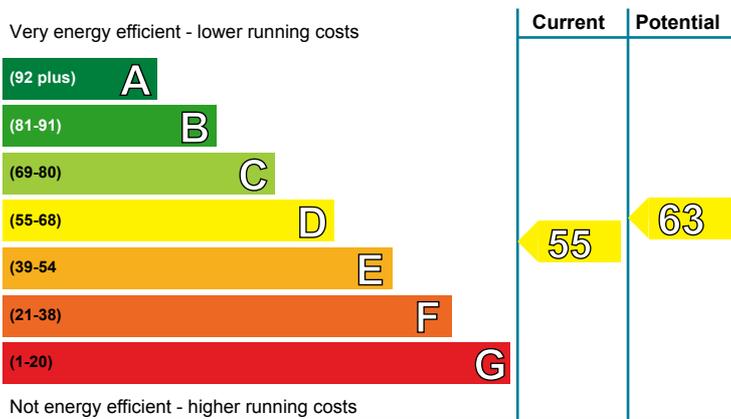
Energy Efficiency Rating

This graph shows the current efficiency of your home, taking into account both energy efficiency and fuel costs. The higher this rating, the lower your fuel bills are likely to be.

Your current rating is **band D (55)**. The average rating for EPCs in Scotland is **band D (61)**.

The potential rating shows the effect of undertaking all of the improvement measures listed within your recommendations report.

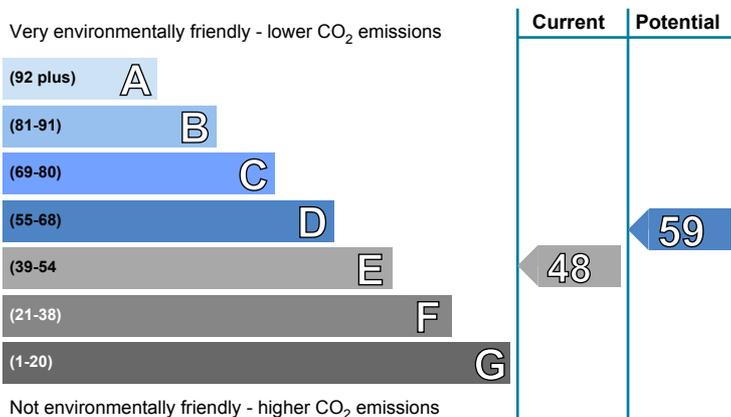
Environmental Impact (CO₂) Rating

This graph shows the effect of your home on the environment in terms of carbon dioxide (CO₂) emissions. The higher the rating, the less impact it has on the environment.

Your current rating is **band E (48)**. The average rating for EPCs in Scotland is **band D (59)**.

The potential rating shows the effect of undertaking all of the improvement measures listed within your recommendations report.
