FLAT 1/6
161 WEST STREET
GLASGOW
G5 8BN

Home Report

Energy Performance Certificate

FLAT 1/6 , 161 WEST STREET, GLASGOW, G5 8BN

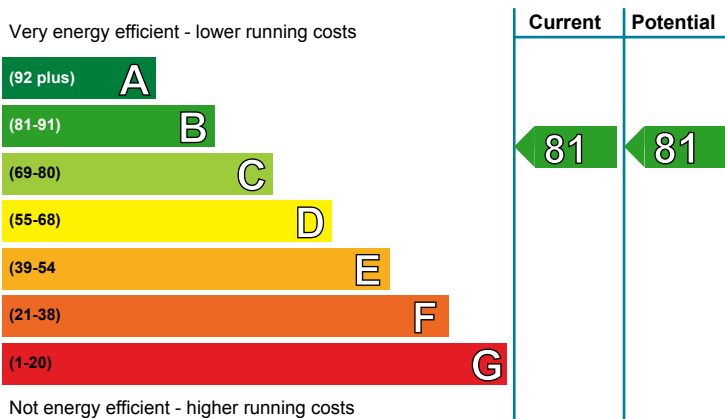
Energy Efficiency Rating

This graph shows the current efficiency of your home, taking into account both energy efficiency and fuel costs. The higher this rating, the lower your fuel bills are likely to be.

Your current rating is **band B (81)**. The average rating for EPCs in Scotland is **band D (61)**.

The potential rating shows the effect of undertaking all of the improvement measures listed within your recommendations report.

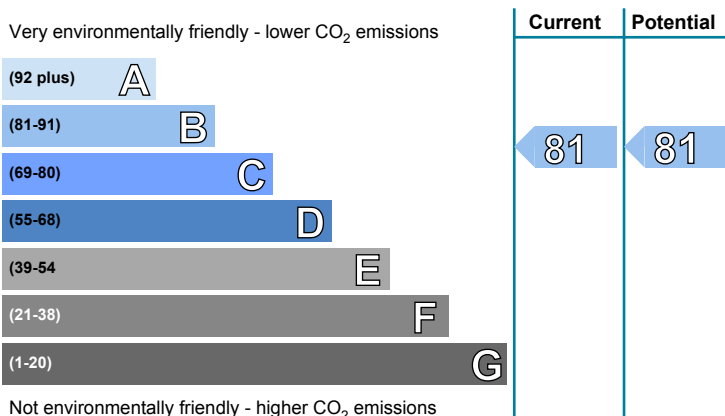
Environmental Impact (CO₂) Rating

This graph shows the effect of your home on the environment in terms of carbon dioxide (CO₂) emissions. The higher the rating, the less impact it has on the environment.

Your current rating is **band B (81)**. The average rating for EPCs in Scotland is **band D (59)**.

The potential rating shows the effect of undertaking all of the improvement measures listed within your recommendations report.
