HOME REPORT

208 SANDPIPER DRIVE
EAST KILBRIDE
GLASGOW
G75 8UW

Energy Performance Certificate (EPC)

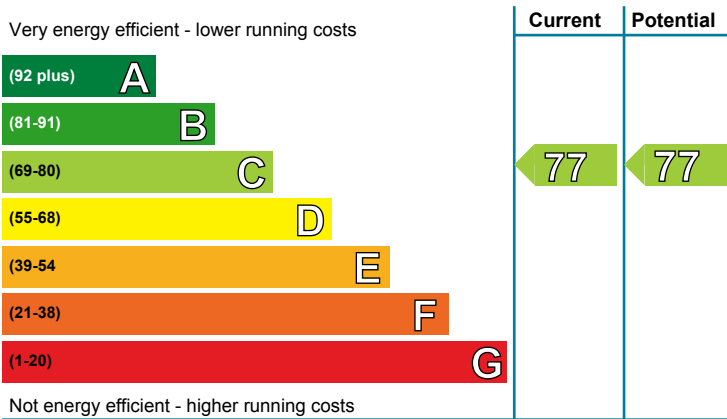
Energy Efficiency Rating

This graph shows the current efficiency of your home, taking into account both energy efficiency and fuel costs. The higher this rating, the lower your fuel bills are likely to be.

Your current rating is **band C (77)**. The average rating for EPCs in Scotland is **band D (61)**.

The potential rating shows the effect of undertaking all of the improvement measures listed within your recommendations report.

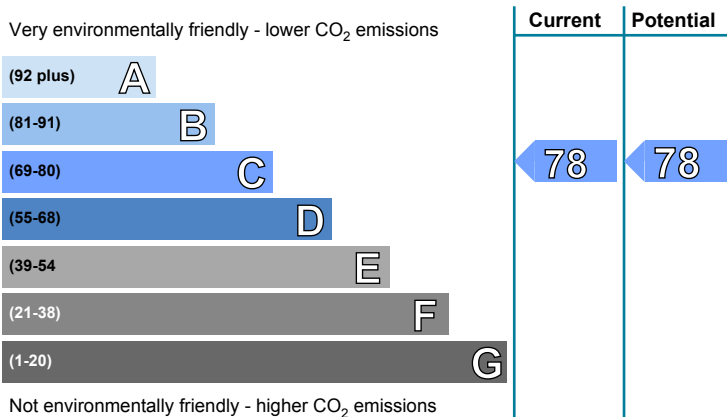
Environmental Impact (CO₂) Rating

This graph shows the effect of your home on the environment in terms of carbon dioxide (CO₂) emissions. The higher the rating, the less impact it has on the environment.

Your current rating is **band C (78)**. The average rating for EPCs in Scotland is **band D (59)**.

The potential rating shows the effect of undertaking all of the improvement measures listed within your recommendations report.
