## HOME REPORT

47 CALDERGLEN ROAD  
EAST KILBRIDE  
GLASGOW  
G74 2JS

# Energy Performance Certificate (EPC)

47 CALDERGLEN ROAD, EAST KILBRIDE, GLASGOW, G74 2JS

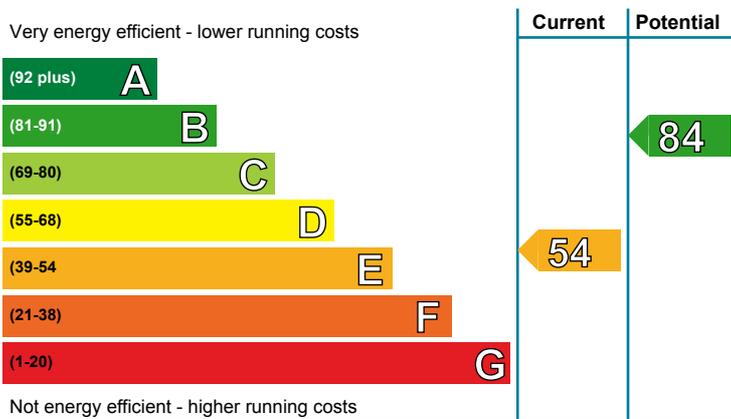
## Energy Efficiency Rating

This graph shows the current efficiency of your home, taking into account both energy efficiency and fuel costs. The higher this rating, the lower your fuel bills are likely to be.

Your current rating is **band E (54)**. The average rating for EPCs in Scotland is **band D (61)**.

The potential rating shows the effect of undertaking all of the improvement measures listed within your recommendations report.

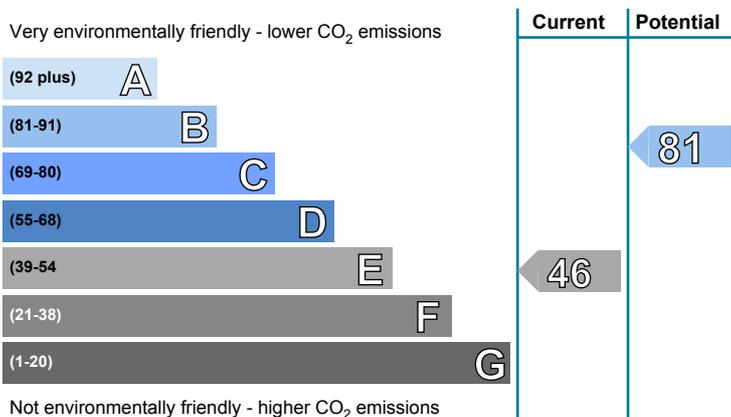
## Environmental Impact (CO<sub>2</sub>) Rating

This graph shows the effect of your home on the environment in terms of carbon dioxide (CO<sub>2</sub>) emissions. The higher the rating, the less impact it has on the environment.

Your current rating is **band E (46)**. The average rating for EPCs in Scotland is **band D (59)**.

The potential rating shows the effect of undertaking all of the improvement measures listed within your recommendations report.
