# **HOME REPORT**

41 SIMPSON DRIVE EAST KILBRIDE GLASGOW G75 0AU

# survey report on:

Property address	41 SIMPSON DRIVE, EAST KILBRIDE, GLASGOW, G75 0AU
Customer	Gillian Valente
Customer address	41 Simpson Drive, East Kilbride, Glasgow, G75 0AU
Prepared by	DM Hall LLP
Date of inspection	8th April 2024

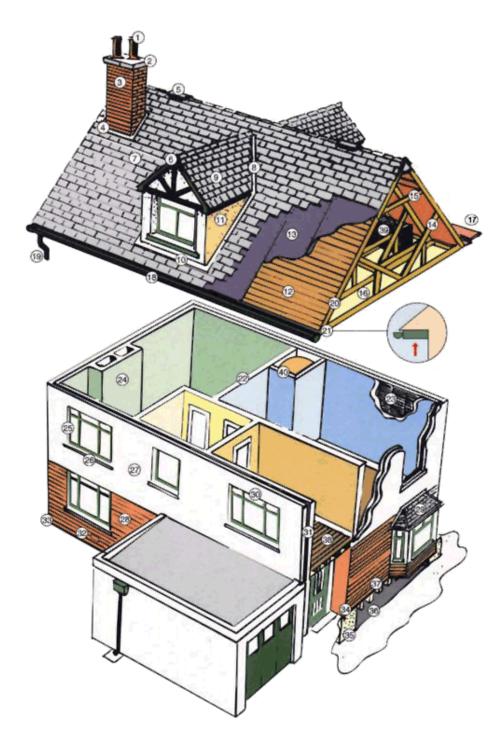
# Sectional Diagram showing elements of a typical house

Reference may be made in this report to some or all of the above component parts of the property. This diagram may assist you in locating and understanding these items.

- 1) Chimney pots
- 2) Coping stone
- 3) Chimney head
- 4 Flashing
- 5) Ridge ventilation
- 6) Ridge board
- 7) Slates / tiles
- 8 Valley guttering
- 9 Dormer projection
- 10 Dormer flashing
- 11) Dormer cheeks
- 12) Sarking
- 13) Roof felt
- (14) Trusses
- (15) Collar
- 16 Insulation
- 17) Parapet gutter
- (18) Eaves guttering
- 19 Rainwater downpipe
- 20) Verge boards/skews
- 21) Soffit boards
- 22) Partition wall
- 23) Lath / plaster
- 24) Chimney breast
- (25) Window pointing
  - 6) Window sills
- 27) Rendering
- (28) Brickwork / pointing
- 29) Bay window projection
- 30 Lintels
- (31) Cavity walls / wall ties
- 32) Subfloor ventilator
- 33 Damp proof course
- 34) Base course
- 35) Foundations
- (36) Solum
- 37) Floor joists
- 38) Floorboards
- 39) Water tank
- 40) Hot water tank
