Home Report

Scottish
Single Survey

| Property address | 129 Glen Nevis East Kilbride Glasgow G74 2BJ |

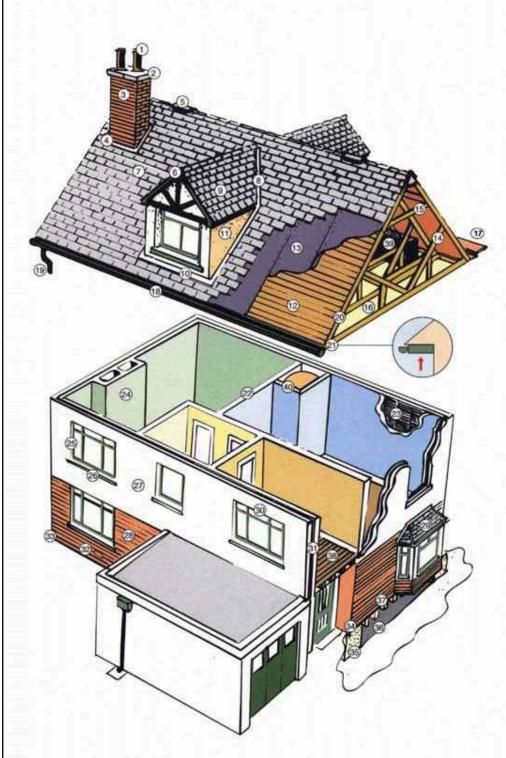
Sectional Diagram showing elements of a typical house

Reference may be made in this report to some or all of the above component parts of the property. This diagram may assist you in locating and understanding these items.

- 1) Chimney pots
- 2) Coping stone
- (3) Chimney head
- (4) Flashing
- 5) Ridge ventilation
- 6) Ridge board
- 7 Slates / tiles
- 8 Valley guttering
- 9 Dormer projection
- 10 Dormer flashing
- 11 Dormer cheeks
- (12) Sarking
- (13) Roof felt
- 14) Trusses
- 15) Collar
- 16) Insulation
- (17) Parapet gutter
- 18) Eaves guttering
- (19) Rainwater downpipe
- 20) Verge boards/skews
- 21) Soffit boards
- 22) Partition wall
- 23) Lath / plaster
- (24) Chimney breast
- 25) Window pointing
- 26) Window sills
- 27) Rendering
- (28) Brickwork / pointing
- 29 Bay window projection
- (30) Lintels
- (31) Cavity walls / wall ties
- 32) Subfloor ventilator
- (33) Damp proof course
- 34) Base course
- 35) Foundations
- 36) Solum
- 37) Floor joists
- 38) Floorboards
- 39) Water tank
- 40) Hot water tank
