Home Report

Scottish
Single Survey

Property address	6 Strathwhillan Drive East Kilbride Glasgow G75 8GT
Customer	Cat and John Donaldson
Customer address	6 Strathwhillan Drive East Kilbride Glasgow G75 8GT
Prepared by	Shepherd Chartered Surveyors
Date of inspection	03/04/2025

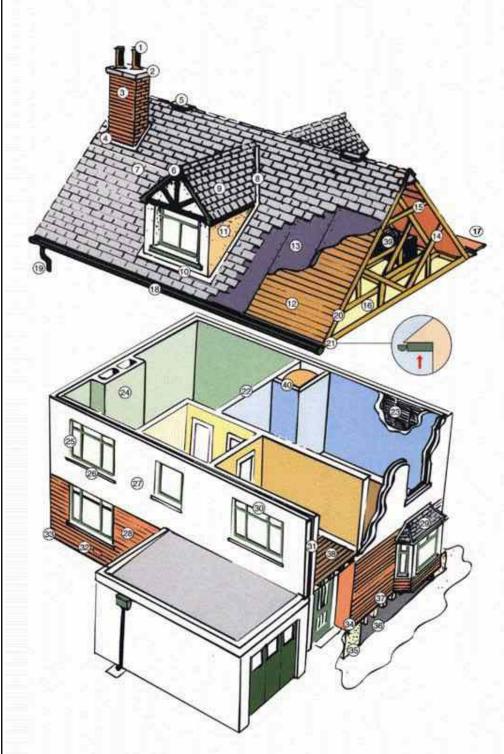
Sectional Diagram showing elements of a typical house

Reference may be made in this report to some or all of the above component parts of the property. This diagram may assist you in locating and understanding these items.

- 1) Chimney pots
- 2) Coping stone
- 3) Chimney head
- (4) Flashing
- 5) Ridge ventilation
- 6 Ridge board
- 7 Slates / tiles
- 8 Valley guttering
- 9 Dormer projection
- 10 Dormer flashing
- 11) Dormer cheeks
- (12) Sarking
- (13) Roof felt
- (14) Trusses
- (15) Collar
- 16) Insulation
- (17) Parapet gutter
- 18) Eaves guttering
- (19) Rainwater downpipe
- 20) Verge boards /skews
- 21) Soffit boards
- 22) Partition wall
- 23) Lath / plaster
- (24) Chimney breast
- 25) Window pointing
- 26) Window sills
- 27) Rendering
- 28) Brickwork / pointing
- 29) Bay window projection
- (30) Lintels
- (31) Cavity walls / wall ties
- 32) Subfloor ventilator
- (33) Damp proof course
- 34) Base course
- 35) Foundations
- 36) Solum
- 7) Floor joists
- 38) Floorboards
- 39) Water tank
- 40) Hot water tank
