Home Report

Scottish
Single Survey

Property address	6 Cragdale East Kilbride Glasgow G74 4QJ
Customer	Alan McMeekin
Customer address	6 Cragdale East Kilbride Glasgow G74 4QJ
Prepared by	Shepherd Chartered Surveyors
Date of inspection	10/04/2025

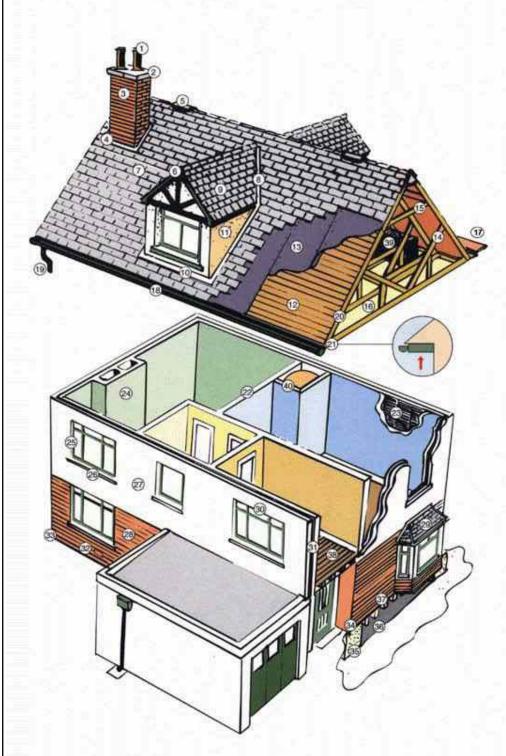
Sectional Diagram showing elements of a typical house

Reference may be made in this report to some or all of the above component parts of the property. This diagram may assist you in locating and understanding these items.

- 1) Chimney pots
- 2) Coping stone
- 3 Chimney head
- (4) Flashing
- 5) Ridge ventilation
- 6 Ridge board
- (7) Slates / tiles
- 8 Valley guttering
- Dormer projection
- 10 Dormer flashing
- 11) Dormer cheeks
- 12) Sarking
- 13) Roof felt
- (14) Trusses
- (15) Collar
- 16 Insulation
- (17) Parapet gutter
- 18) Eaves guttering
- (19) Rainwater downpipe
- 20) Verge boards/skews
- 21) Soffit boards
- 22) Partition wall
- 23) Lath / plaster
- 24) Chimney breast
- 25) Window pointing
- 26) Window sills
- 27) Rendering
- 28) Brickwork / pointing
- 29 Bay window projection
- (30) Lintels
- (31) Cavity walls / wall ties
- 32) Subfloor ventilator
- (33) Damp proof course
- 34) Base course
- 35) Foundations
- 36) Solum
- 37) Floor joists
- 38) Floorboards
- 39) Water tank
- 40) Hot water tank
