123 Gavin Street,  
Motherwell,  
Lanarkshire,  
ML1 2RL

# Home Report

# Single Survey

<b>Property Address</b>	123 Gavin Street, Motherwell, Lanarkshire, ML1 2RL
<b>Reference</b>	1069720
<b>Customer Name</b>	Eilidh Hannigan
<b>Date of Inspection</b>	23rd May 2025
<b>Surveyor's name, qualifications and office</b>	Martin Fleming DM Hall LLP Chartered Surveyors Unit 3, Cadzow Park 82 Muir Street Hamilton ML3 6BJ  Tel: 01698 284939  email: hamiltonresidential@dmhall.co.uk
<b>Prepared By</b>	DM Hall LLP

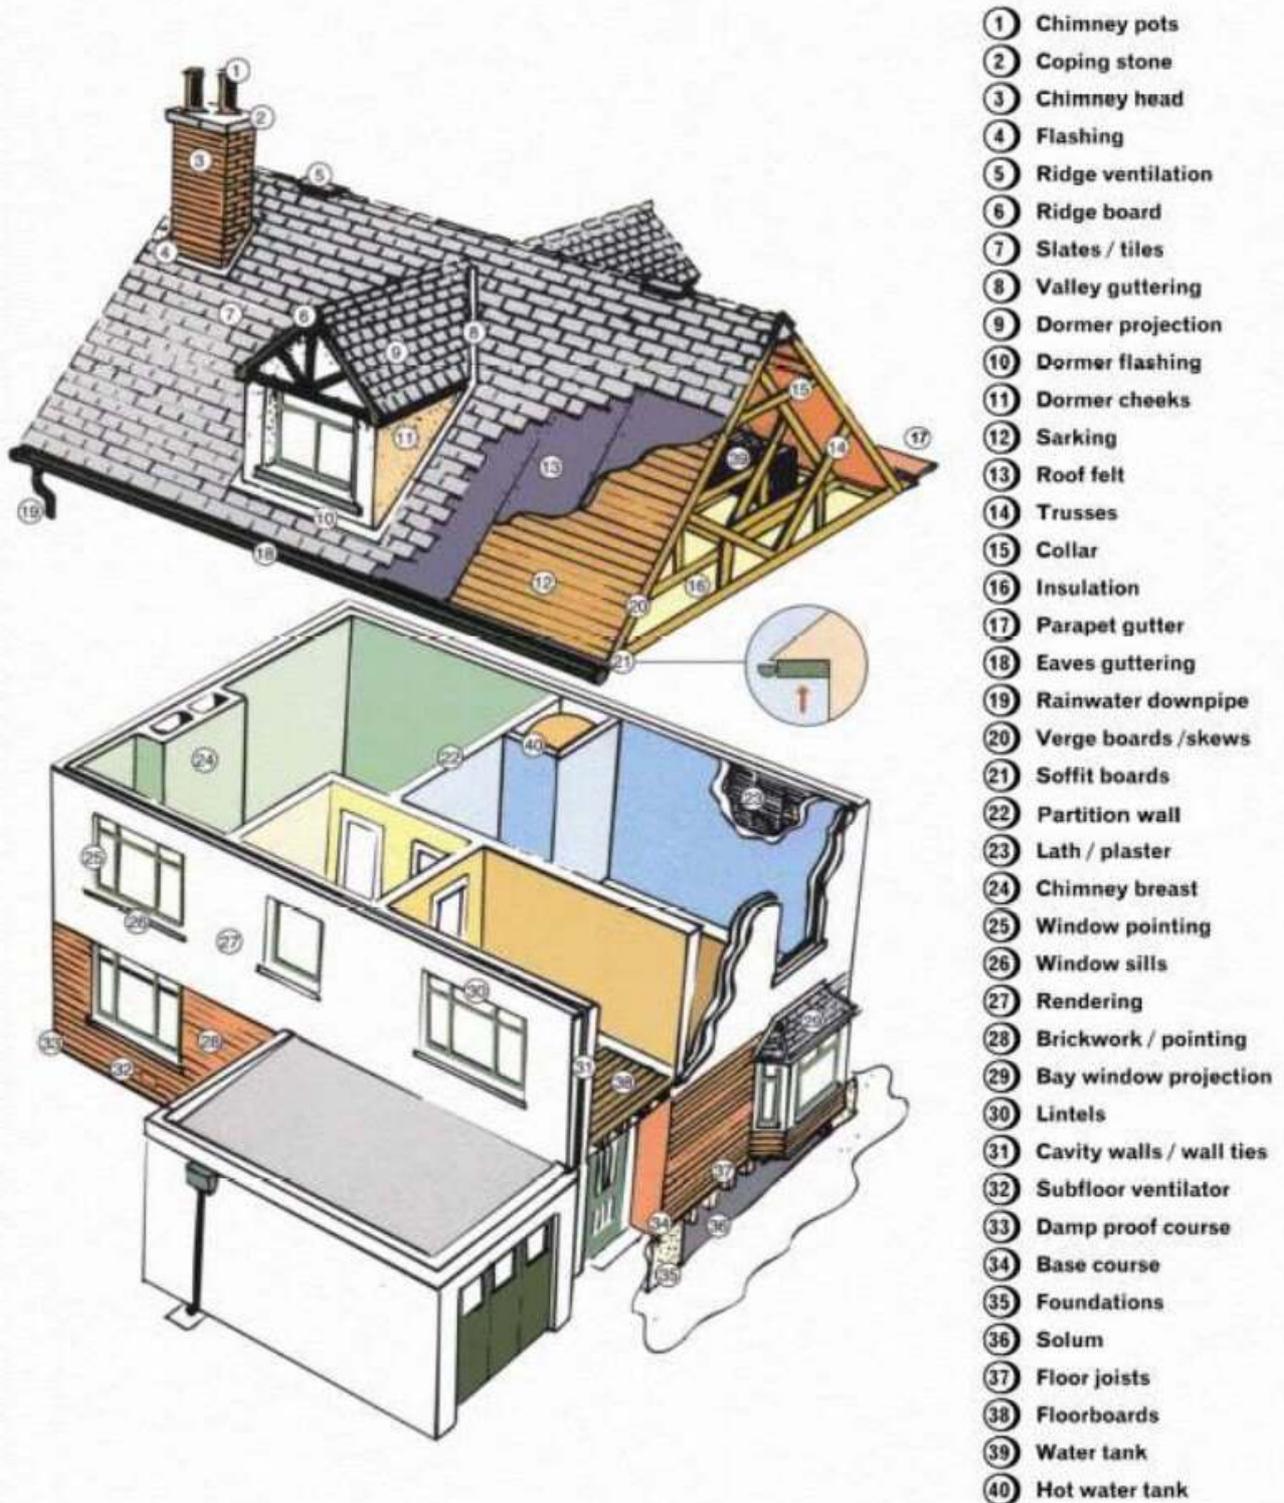
## Sectional Diagram showing elements of a typical house

Reference may be made in this report to some or all of the above component parts of the property. This diagram may assist you in locating and understanding these items.
